Air Hoses: A Closer Look

By Francois Burman,
Pr. Eng, MSc.

After we published the article “Invisible Crystals” (Gear, Winter 2017), divers have continued to send us failed hoses.

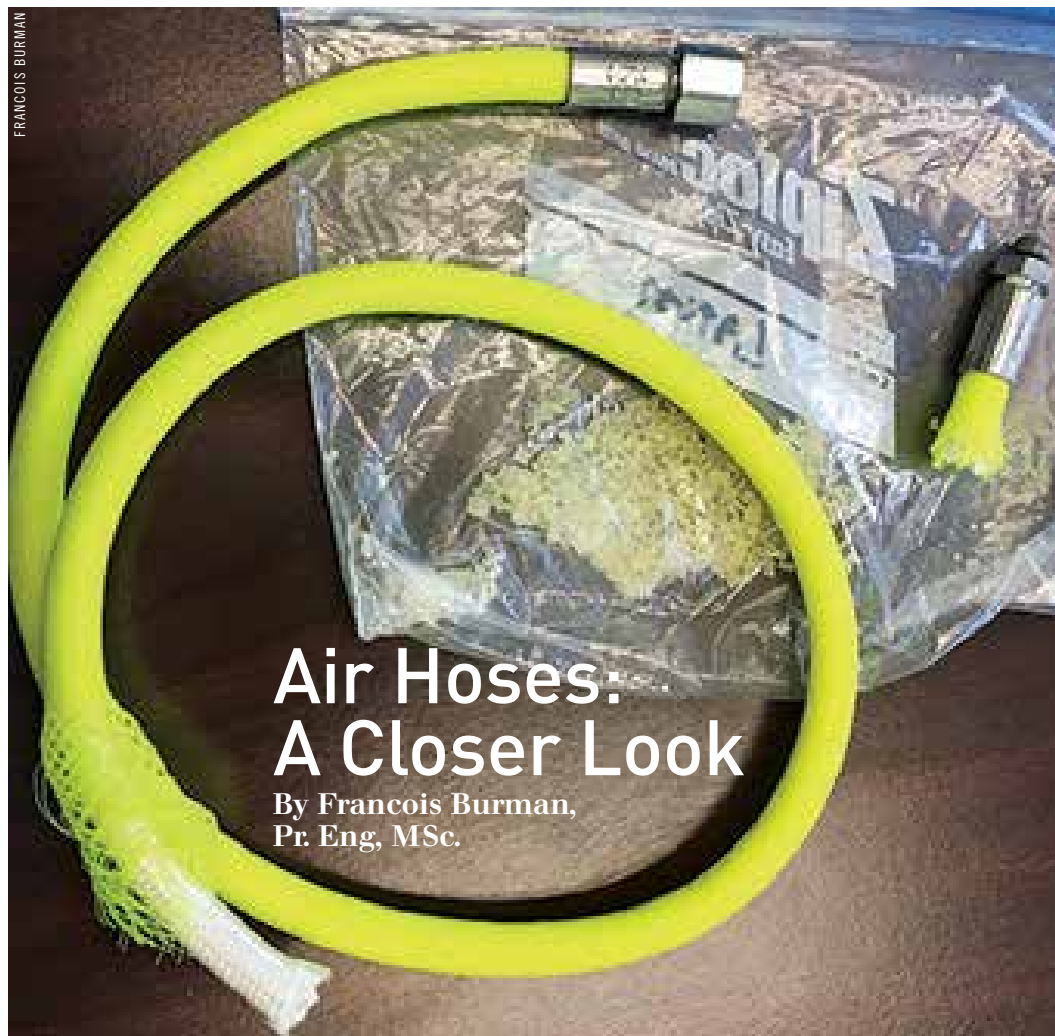
Opposite, clockwise from top: This hose features both a degraded outer lining and an embrittled inner hose. High-quality hoses should indicate the manufacturer’s mark of quality assurance: polyether-polyurethane single lining inner hose. Accelerated aging of a polyester-polyurethane hose lining reveals degradation.

The decay product, a yellow crystalline-looking substance, is softer than it appears and feels waxy when squeezed. We previously referred to this

substance as the product of “polymorphic crystallization,” but the reaction in question is actually hydrolysis, which, as its name implies, requires the presence of water. Elevated temperature promotes accelerated degradation or hydrolysis of the polyester-TPU.
